July 1996
NSRP 0471

Evaluation of New Surface Preparation and Coating Repair Techniques in Ballast Tanks - Phase III

U.S. DEPARTMENT OF THE NAVY
CARDEROCK DIVISION,
NAVAL SURFACE WARFARE CENTER

in cooperation with
Peterson Builders, Inc.

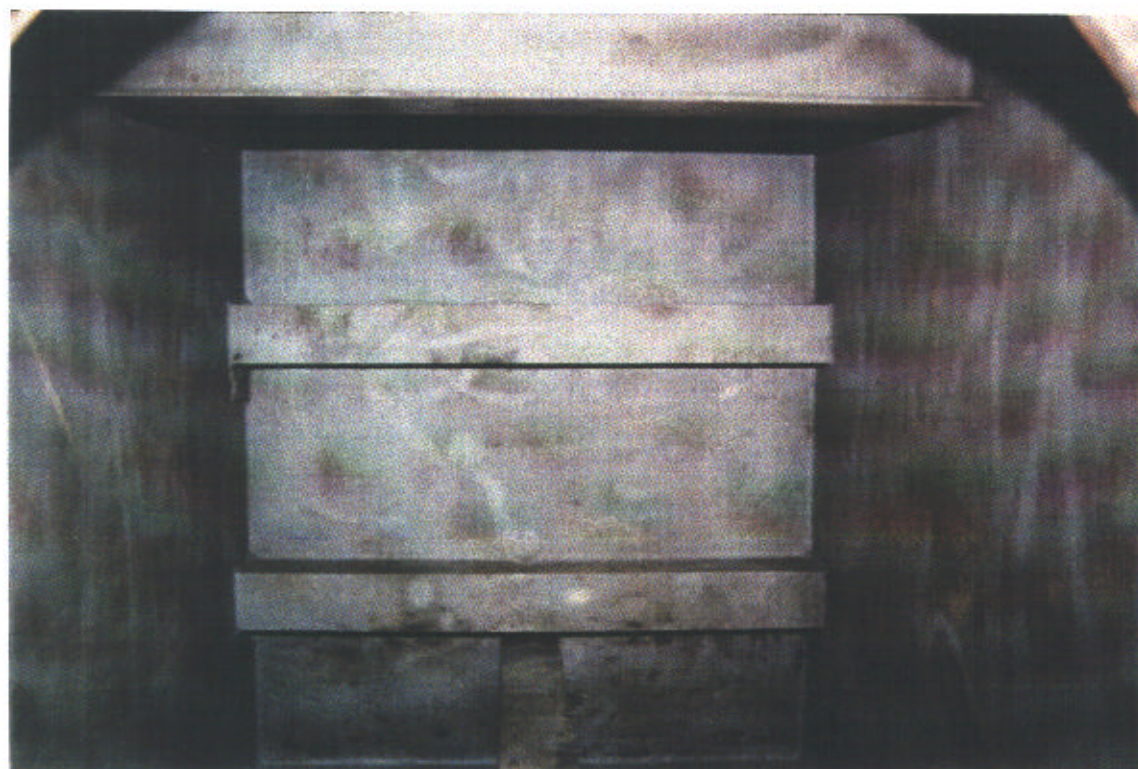
During abrasive blast surface preparation it was difficult to achieve a true SSPC-SP 10, "Near white Blast Clean" surface. Due to the high chloride contamination of the corroded steel, the blasted surface would flash rust within a matter of minutes. See Photograph 2. This statement holds true for all the tanks which were reblasted for this phase of the project.

No attempt was made to remove the chloride contamination other than that accomplished by the surface preparation technique. The chloride levels were determined to be 5 milligrams per square meter for Near White Blast Cleaned surfaces. This may seem low, based on the fact that the surface preparation flash rusted in a less than four hours; but may be due to the limitation of the swab technique used to determine chloride contamination. Sodium chloride salts bound up as ferric or ferrous chloride and combined with other complex salts could have influenced the volatility of the salts removed. After allowing the solution to set for three hours, the conductance of the solution increased resulting in a revised reading of 15 milligrams per square meter.

PHOTOGRAPH 2-NEAR WHITE BLAST SHOWING FLASH RUST

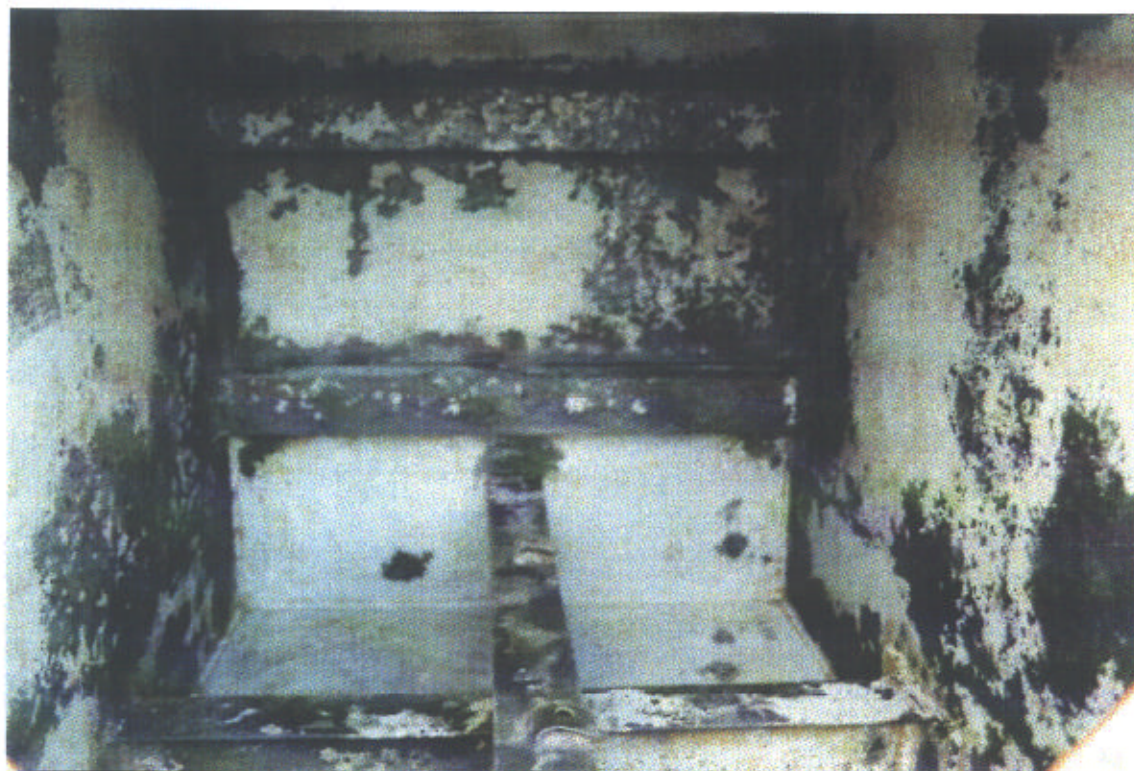
PHOTOGRAPH 4-POWER/HAND TOOL CLEANED SURFACE PRIOR TO COATING

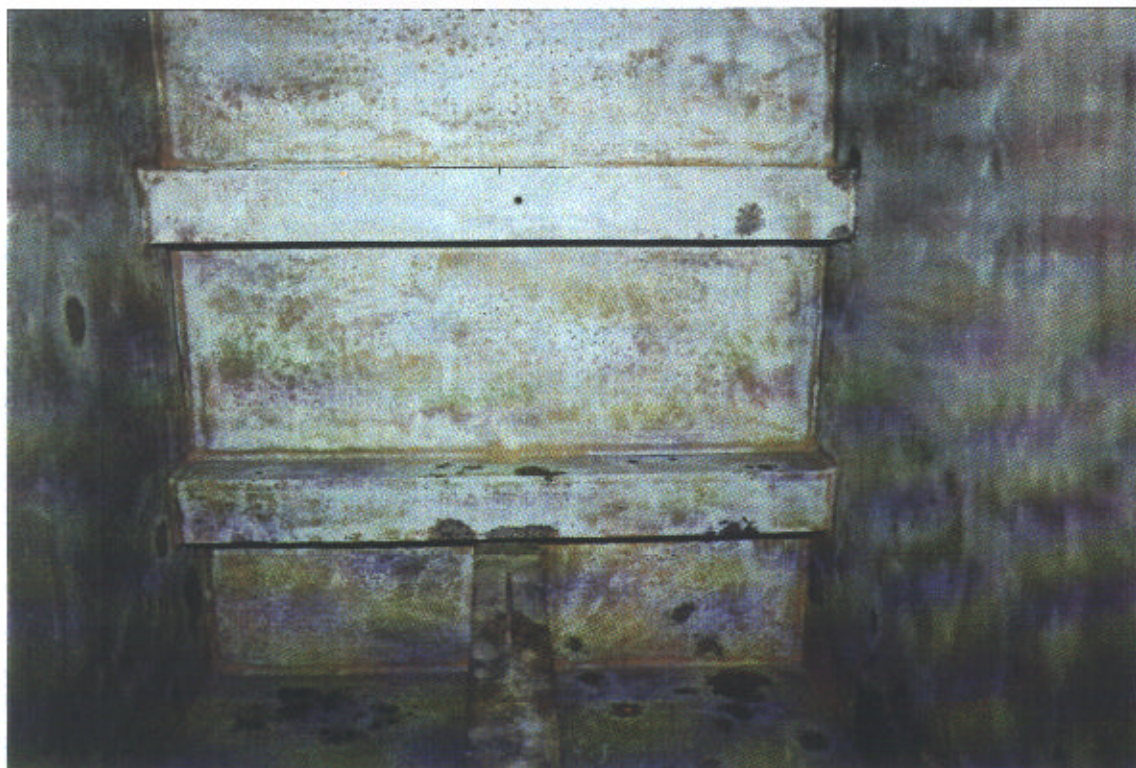
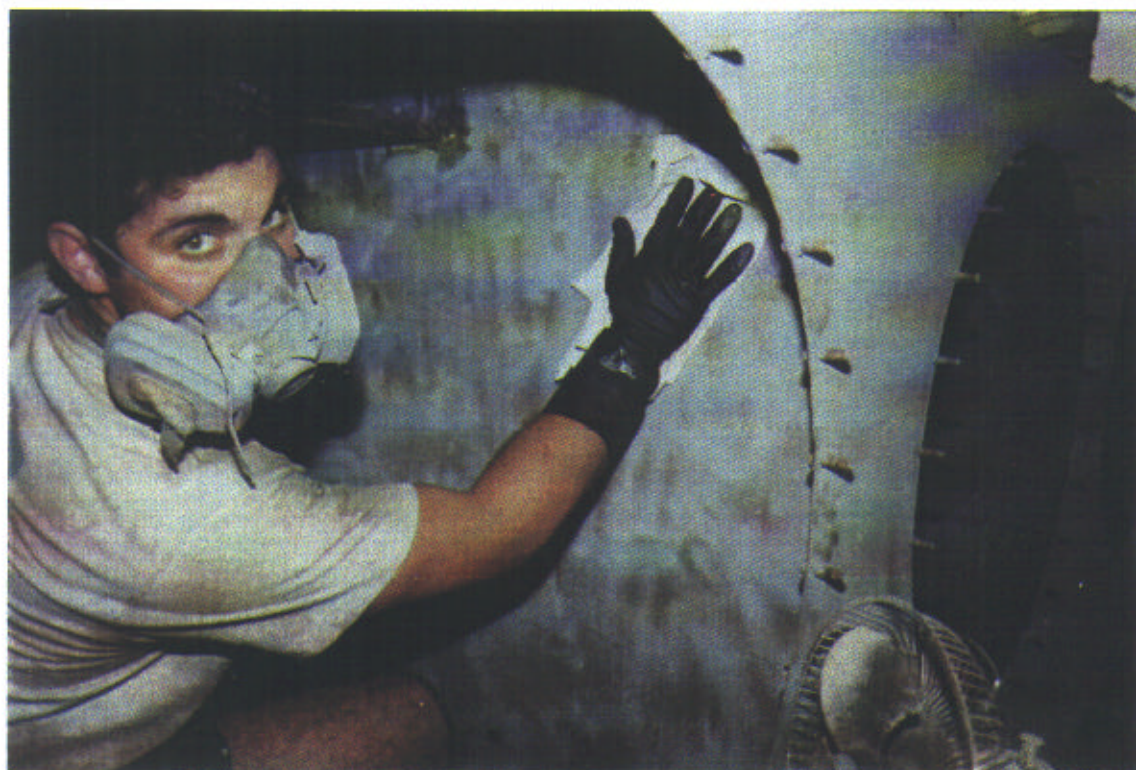
PHOTOGRAPH 5-SURFACE PREPARATION OF INTACT MIL-P-24441

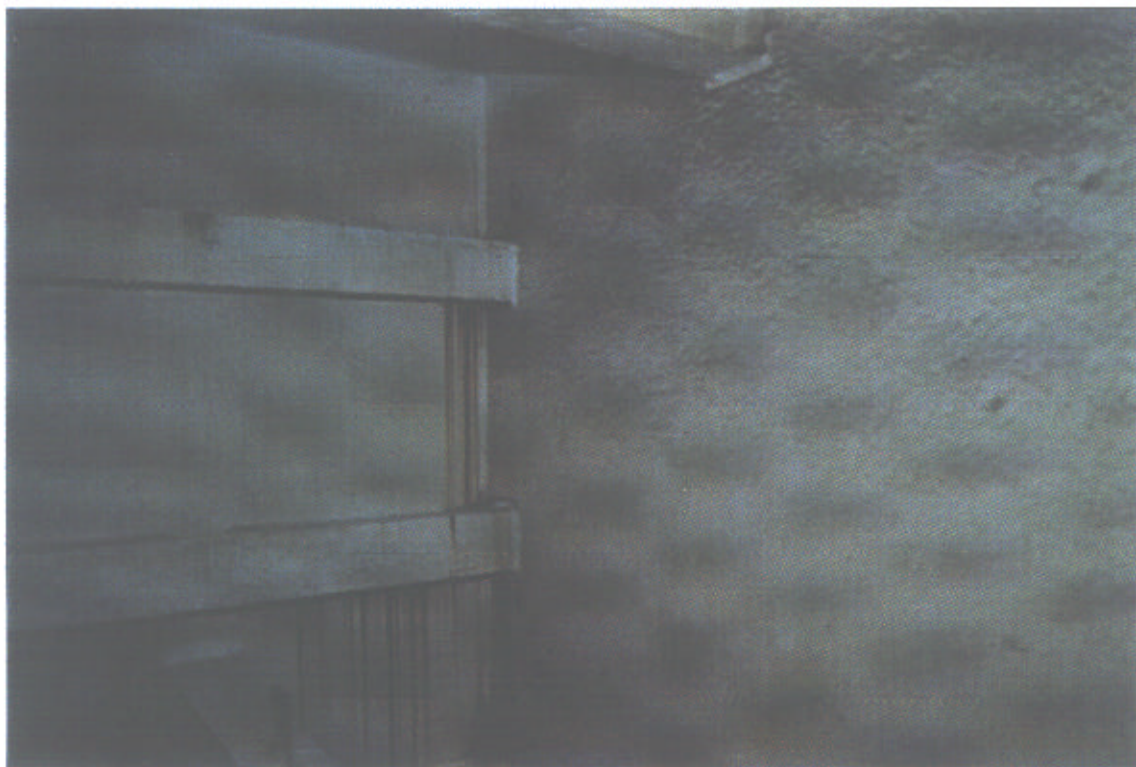
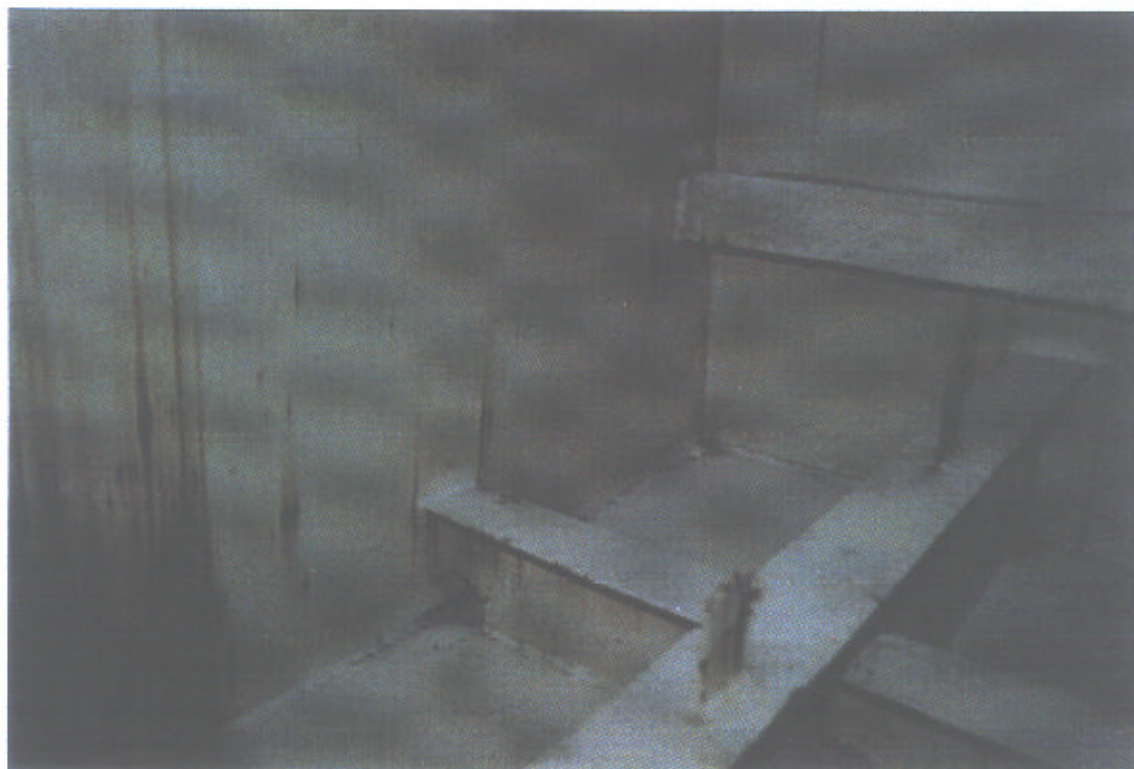
Tank 4 has an overall ASTM rating of rust grade 9 with one area on the left side, bottom front quadrant graded as a 7. The performance of this system over Sweep Blast Cleaned (SP 7) steel is marginally better than the same system applied over hand and power tool cleaned steel. See photograph 9.

TANK FOUR	COATING SYSTEM: SURFACE TOLERANT EPOXY A VOC COMPLIANT (AMERON 385P/385) (SYSTEM LIFE-3 YEARS) SURFACE PREPARATION: SP-7 PREVIOUS SYSTEM: SAME OVER SP-10
TOP-FLAT DET-16.2 MILS	RUST GRADE 10 CLER CONDITION # 1
TOP-STIFFENER DFT-13.6 MILS	RUST GRADE 9. NO EDGE BREAKDOWN. EDGE OF STIFFENER 1/8 INCH THICK TAPERING UP TO FULL THICKNESS. CLER CONDITION # 1
BACK-FLAT DFT-15.8 MILS	RUST GRADE 9. SOME RUST STREAKS. CLER CONDITION # 2
BACK-TOP STIFFENER DFT-18.2 MILS	RUST GRADE 9. 3/16 INCH THICKNESS REMAINING. CLER CONDITION # 2
BACK-BOTTOM STIFFENER DFT-14.4 MILS	RUST GRADE 9. 3/16 INCH THICKNESS REMAINING. CLER CONDITION # 2
BOTTOM-FLAT DFT-19.8 MILS	RUST GRADE 9 CLER CONDITION # 1
BOTTOM- STIFFENER DFT-17 MILS	RUST GRADE 9. MINOR EDGE BREAKDOWN. 3/16 INCH THICKNESS REMAINING. CLER CONDITION # 1
BOTTOM-FRAME DFT-15 MILS	RUST GRADE 9. 1/16 INCH THICKNESS REMAINING ON FLANGE EDGE; 3/16 INCH THICKNESS REMAINING ON WEB. CLER CONDITION # 1

RIGHT SIDE DFT-13.1 MILS	RUST GRADE 9 CLER CONDITION # 1
LEFT SIDE DFT-14.9 MILS	BOTTOM FRONT QUADRANT 7. BALANCE 9 CLER CONDITION # 2

PHOTOGRAPH 9-SURFACE TOLERANT EPOXY "A" OVER SWEEP BLAST CLEANING

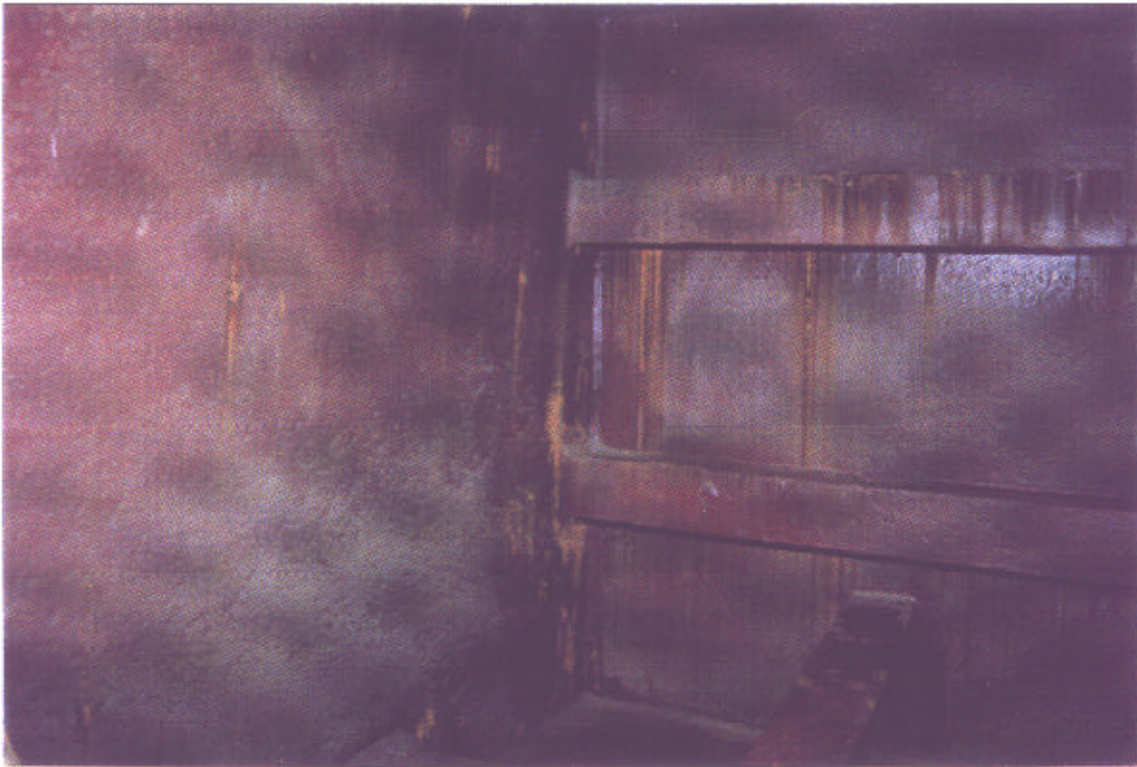
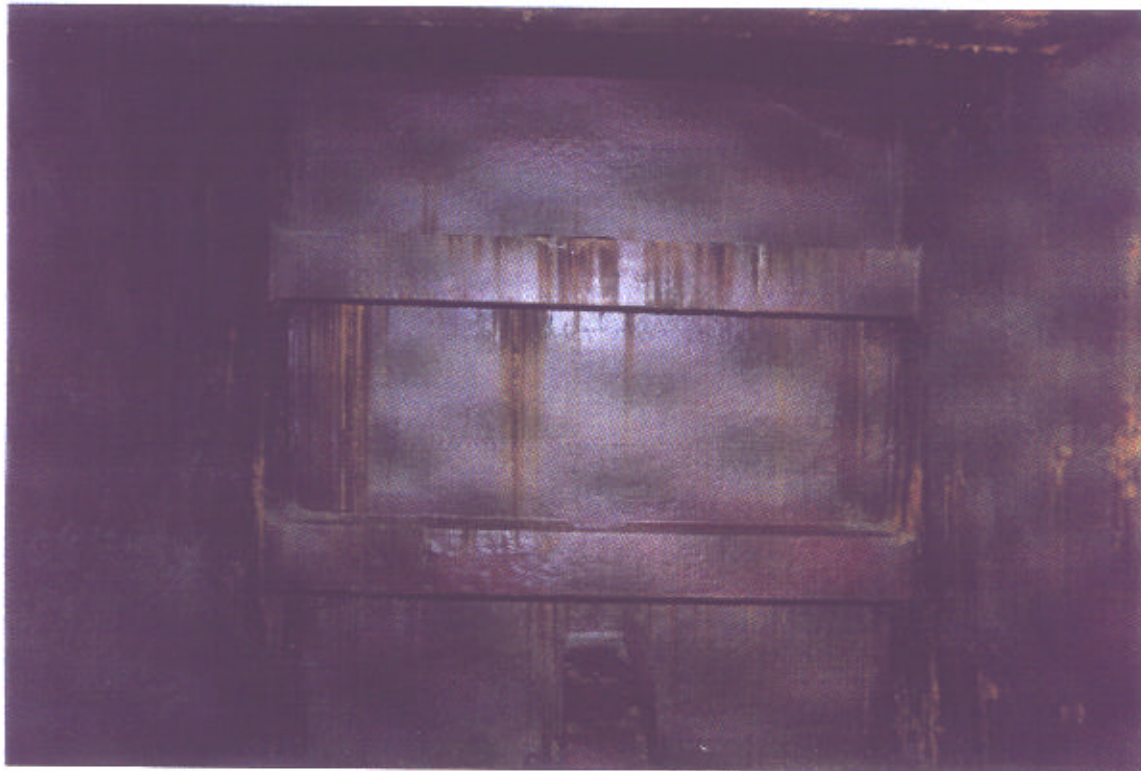
The Epoxy "B" coated tank 5 has been under test for a total of eleven years. Following the initial six years of testing, this system was beginning to show significant breakdown. The top of the tank had twenty-five to fifty percent failure. The right side of the tank had totally failed. The balance of the tank had between five and ten percent failure.

After three additional years of testing (eleven total), the top overhead and top back stiffener has major edge breakdown. The right side lower left quadrant has also failed. This is an interesting observation in that no matter which coating system has been applied to this tank, this exact location fails during each test project. The reason for this unique failure is not known but it is believed that microbiological influenced corrosion (MIC) may be the cause. See photograph 10.

TANK FIVE	COATING SYSTEM: SURFACE TOLERANT SYSTEM B (DEVOE 235) (SYSTEM AGE 11 YEARS) SURFACE PREPARATION : SP-2 MINOR AREAS ONLY @ 8 YEARS PREVIOUS SYSTEM: SYSTEM "B" W/SP-6. SP-2 REPAIRED @ 6 AND 8 YEARS.
TOP-FLAT DFT-14.4 MILS	RUST GRADE 10. CLER CONDITION # 1
TOP-STIFFENER DFT-15.3 MILS	EDGE BREAKDOWN. RUST GRADE 9 BALANCE. NO SIGNIFICANT METAL LOSS. 75% OF EDGE HAS FAILED. CLER CONDITION # 3
BACK-FLAT DFT-18 MILS	RUST GRADE 9. CLER CONDITION # 1
BACK-TOP STIFFENER DFT-21.8 MILS	TOP OF STIFFENER IS DELAMINATING AND LIFTING. BALANCE RUST GRADE 9. NO SIGNIFICANT METAL LOSS. CLER CONDITION # 3
BACK-BOTTOM STIFFENER DFT-22.4 MILS	RUST GRADE 9. NO SIGNIFICANT METAL LOSS. CLER CONDITION # 1
BOTTOM-FLAT DFT-16.4 MILS	RUST GRADE 9 CLER CONDITION # 1
BOTTOM- STIFFENER DFT-	RUST GRADE 9. NO SIGNIFICANT METAL LOSS. CLER CONDITION # 1
BOTTOM-FRAME DFT-24.9 MILS	RUST GRADE 9. NO SIGNIFICANT METAL LOSS. CLER CONDITION # 1

RIGHT SIDE DFT-16.7 MILS	RUST GRADE 7. LOWER LEFT QUADRANT FAILED. THIS SAME AREA HAS FAILED EACH TIME A NEW COATING SYSTEM HAS BEEN APPLIED. CLER CONDITION # 2
LEFT SIDE DFT-12.3 MILS	RUST GRADE 8 CLER CONDITION # 2

PHOTOGRAPH 10-REPAIRED SURFACE TOLERANT EPOXY "B"

The system was repaired using hand tool cleaning (SSPC-SP 2). After another two years of testing, the overall failure was less than one percent with only minor breakdown on the edges of the overhead stiffener. No failure was observed on the balance of the structure. The coating system was only spot repaired at this time.

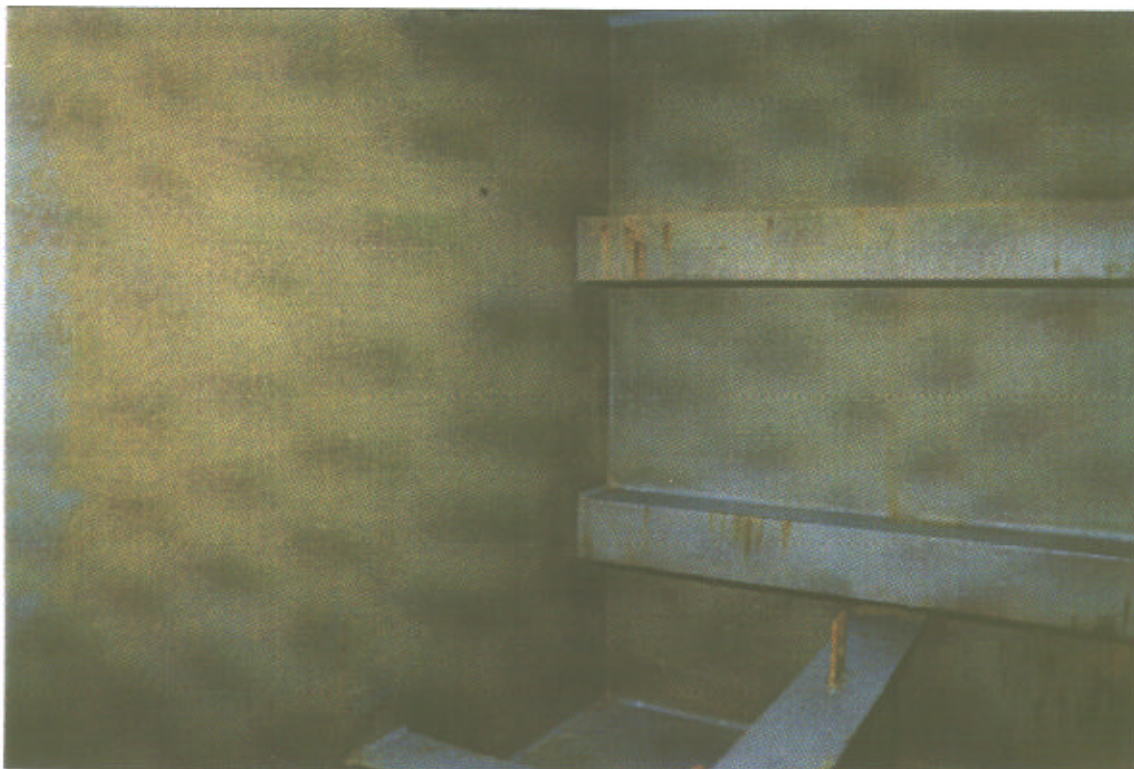
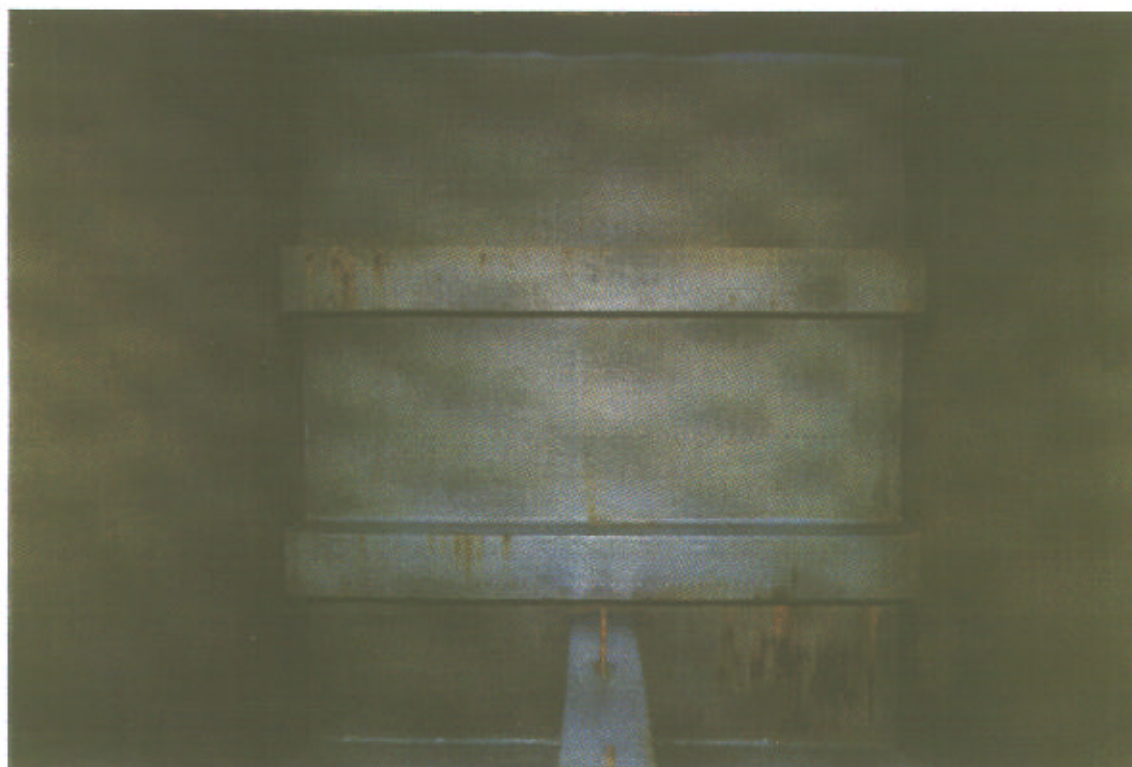
Except for some edge breakdown on the top overhead stiffener, the coating system in Tank 7 is providing corrosion protection after eight years of testing. The overall failure is less than one percent. See photograph 11.

TANK SEVEN	COATING SYSTEM : VOC COMPLIANT MIL-P-24441 REPAIRED W/MIL-P-24441 (AMERON ORIGINALLY; REPAIRED WITH DEVOE) (SYSTEM LIFE-ORIGINAL SYSTEM REPAIRED AFTER 5 YEARS. REPAIR AREAS 3 YEARS. TOTAL 8 YEARS) SURFACE PREPARATION: SP-2/3 PREVIOUS SYSTEM: SAME W/SP-10 SURFACE PREPARATION
TOP-FLAT DFT-7.7 MILS	RUST GRADE 9 CLER CONDITION # 1
TOP-STIFFENER DFT-11.8 MILS	BREAKDOWN ON EDGES. RUST GRADE 8 BALANCE. CLER CONDITION # 2
BACK-FLAT DFT-12.9 MILS	TOP AND CENTER-RUST GRADE 10. BOTTOM RIGHT-RUST GRADE 7. RUST GRADE 10 BALANCE OF BOTTOM. CLER CONDITION # 1
BACK-TOP STIFFENER DFT-14.6 MILS	RUST GRADE 8 CLER CONDITION # 2
BACK-BOTTOM STIFFENER DFT-17.3 MILS	RUST GRADE 9 CLER CONDITION # 1
BOTTOM-FLAT DFT-16.6 MILS	RUST GRADE 9 CLER CONDITION # 1
BOTTOM- STIFFENER DFT-13.6 MILS	RUST GRADE 9 CLER CONDITION # 1
BOTTOM-FRAME DFT-15 MILS	RUST GRADE 7 CLER CONDITION # 2
RIGHT SIDE DFT-15.8 MILS	RUST GRADE 9 CLER CONDITION # 1

LEFT SIDE DFT-14.9 MILS	RUST GRADE 9 CLER CONDITION # 1

PHOTOGRAPH 11-REPAIRED AND OVERCOATED MIL-P-24441

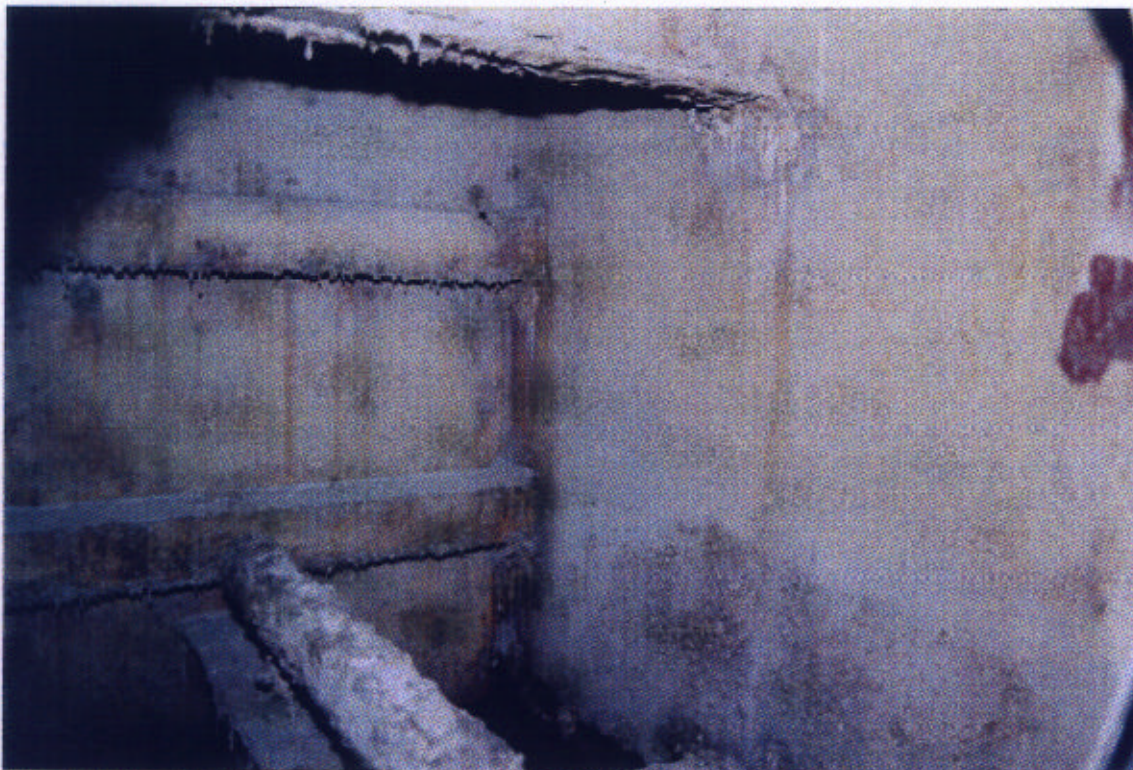
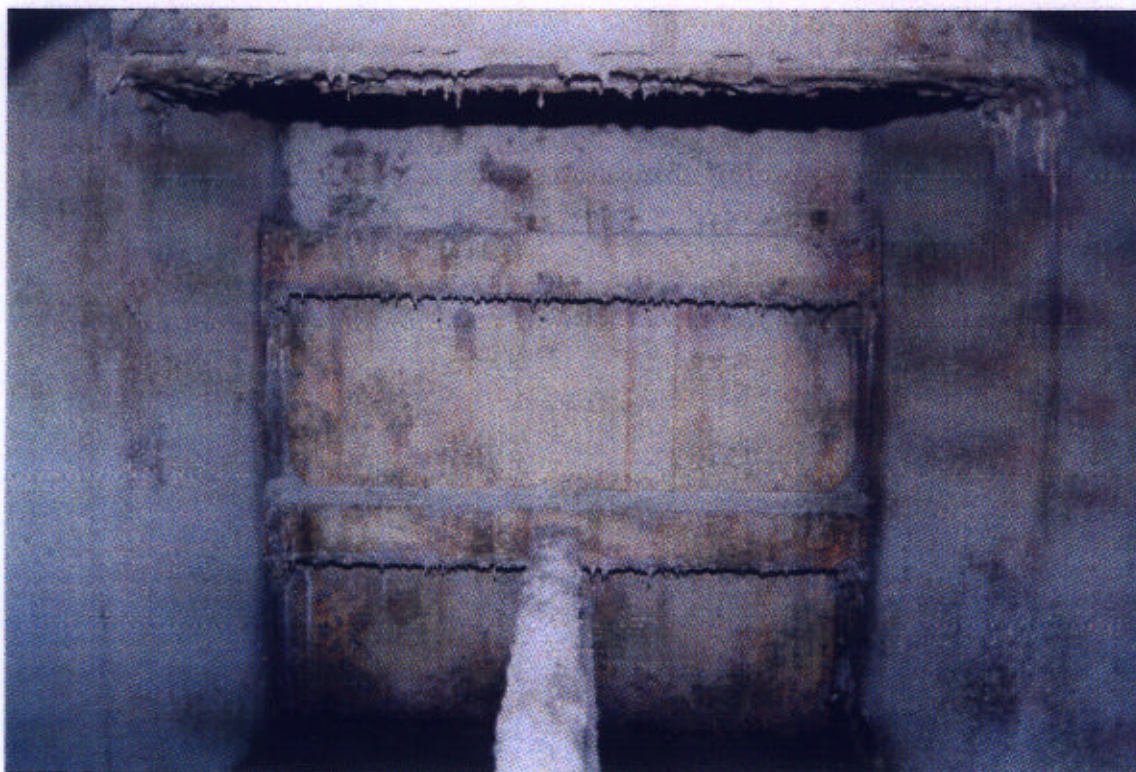
No change was noted in Tank 2 since the last report. No new coating failure was detected. Calcareous deposits continue to increase. Very little anode consumption was noted. This system is sixteen years old. A zinc anode was added after six years. See photograph 12.

TANK TWO	COATING SYSTEM: MIL-P-23236 COATING WITH ZINC ANODE (SYSTEM LIFE-15 YEARS) ORIGINAL DRY FILM THICKNESS RECORDED AS 6.5 to 8.5 MILS. SURFACE PREPARATION: SP-10 PREVIOUS SYSTEM: ANODE ADDED AFTER 6 YEARS OF TESTING
TOP-FLAT	NO DETECTABLE CHANGE FROM LAST GRADE PERIOD. CLER CONDITION # 4
TOP-STIFFENER	NO DETECTABLE CHANGE FROM LAST GRADE PERIOD. 3/16 INCH THICKNESS REMAINING CLER CONDITION # 4
BACK-FLAT	NO DETECTABLE CHANGE FROM LAST GRADE PERIOD. CLER CONDITION # 4
BACK-TOP STIFFENER	NO DETECTABLE CHANGE FROM LAST GRADE PERIOD. NO SIGNIFICANT METAL LOSS. CLER CONDITION # 4
BACK-BOTTOM STIFFENER	NO DETECTABLE CHANGE FROM LAST GRADE PERIOD. NO SIGNIFICANT METAL LOSS. CLER CONDITION # 4
BOTTOM-FLAT	BEGINNING TO SCALE. SCALE WORSE THAN LAST GRADE PERIOD. NEEDS REPAIR. CLER CONDITION # 4
BOTTOM-STIFFENER	NO DETECTABLE CHANGE FROM LAST GRADE PERIOD. 3/16 INCH THICKNESS REMAINING. CLER CONDITION # 4

BOTTOM-FRAME	NO DETECTABLE CHANGE FROM LAST GRADE PERIOD. 1/8 INCH THICKNESS REMAINING. CLER CONDITION # 4
RIGHT SIDE	NO DETECTABLE CHANGE FROM LAST GRADE PERIOD CLER CONDITION # 4
LEFT SIDE	NO DETECTABLE CHANGE FROM LAST GRADE PERIOD CLER CONDITION # 4

PHOTOGRAPH 12-AGED COATING (MIL-P-23236) WITH ADDED ZINC ANODE

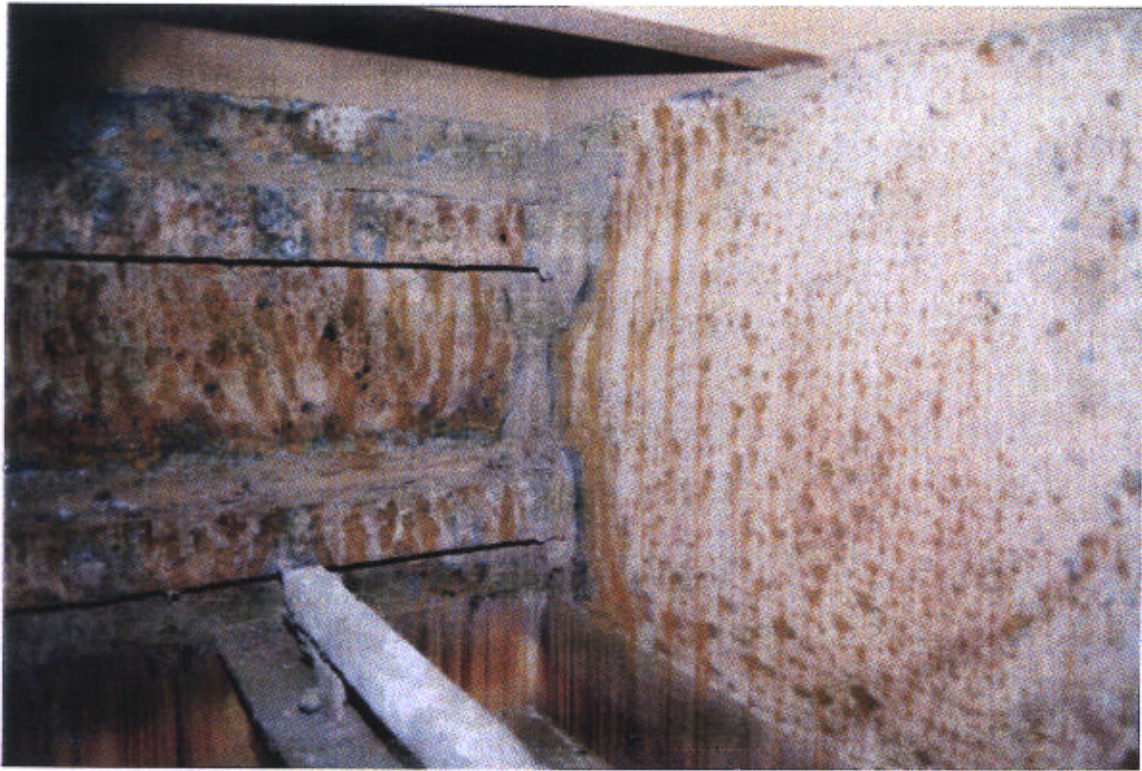
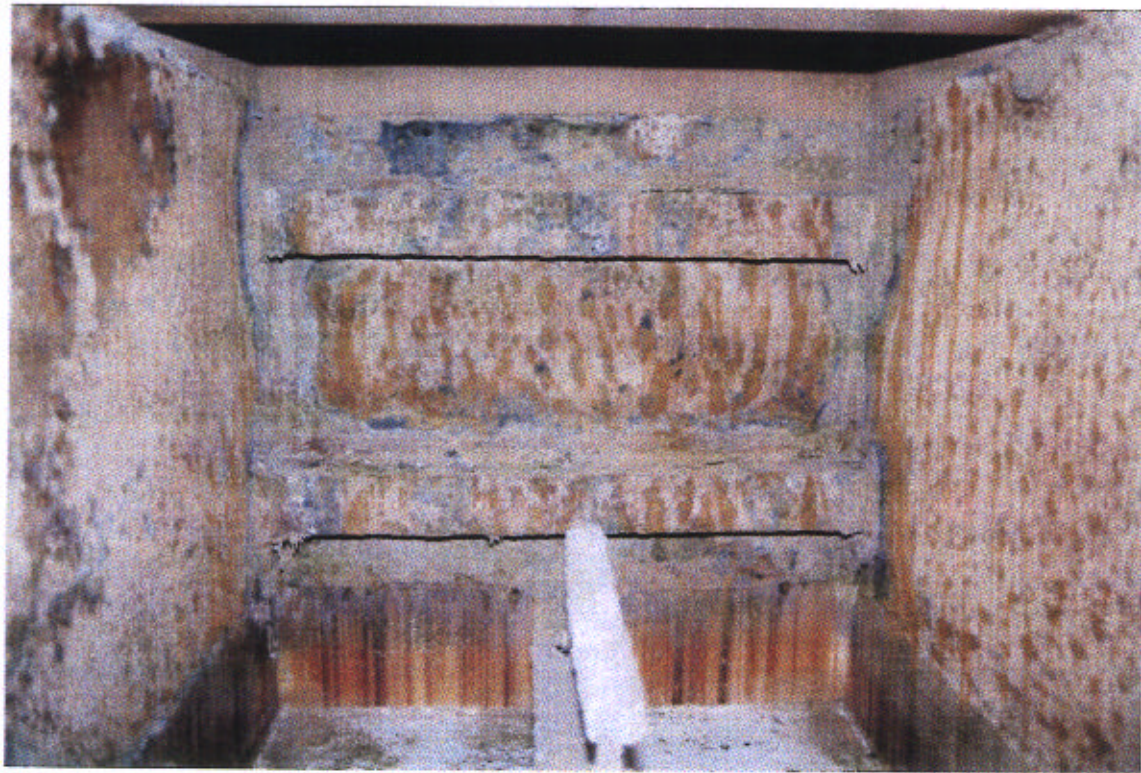
After sixteen years of testing, Tank 3 is still providing protection to the steel substrate. The zinc anode (50 pound) was replaced after twelve years with a new Thermal Reduction Company TRC-TZ-50-WC zinc anode (50 pounds). The color of the bare portion of the tank is the color of the calcareous deposit with possibly some red color being picked up due to the system beginning to fail. No significant metal loss was detected on the flat sides and overhead. The stiffener thicknesses loss ranged from 1/8 inch on the back top stiffener to 1/16 on the other stiffeners. The original thickness was 1/4 inch. See photograph 7 showing repaired and recoated bottom prior to re-exposure. Photograph 13 shows performance results to date.

TANK THREE	COATING SYSTEM : MIL-P-23236 PARTIAL WITH ZINC ANODE (SYSTEM LIFE-16 YEARS). DRY FILM THICKNESS FOR COATED AREAS RECORDED AS 6 TO 9.5 MILS. SURFACE PREPARATION: SSPC-SP-10 INITIAL/SP-2 REPAIR OF BOTTOM PREVIOUS SYSTEM: ANODE REPLACED TWELVE YEARS. REPAIRS MADE TO FLAT BOTTOM
TOP-FLAT	NO DETECTABLE CHANGE FROM LAST GRADE PERIOD. CLER CONDITION # 2
TOP-STIFFENER	NO DETECTABLE CHANGE FROM LAST GRADE PERIOD. CLER CONDITION # 1
BACK-FLAT	NO DETECTABLE CHANGE FROM LAST GRADE PERIOD. UNPAINTED AREA (CALCAREOUS SCALE)-CLER CONDITION # 4, PAINTED AREA-CLER CONDITION # 1
BACK-TOP STIFFENER	NO DETECTABLE CHANGE FROM LAST GRADE PERIOD. 1/8 INCH THICKNESS REMAINING. UNPAINTED AREA (CALCAREOUS SCALE)-CLER CONDITION # 4
BACK-BOTTOM STIFFENER	NO DETECTABLE CHANGE FROM LAST GRADE PERIOD. UNPAINTED AREA (CALCAREOUS SCALE)-CLER CONDITION # 4
BOTTOM-FLAT	RUST GRADE 9 CLER CONDITION # 1
BOTTOM-STIFFENER	NO DETECTABLE CHANGE FROM LAST GRADE PERIOD. SOME EDGE EXFOLIATION. 3/16 INCH THICKNESS REMAINING. CLER CONDITION # 3

BOTTOM-FRAME	NO DETECTABLE CHANGE FROM LAST GIUDE PERIOD. SOME EDGE EXFOLIATION. 3/16 INCH THICKNESS REMAINING. CLER CONDITION # 3
RIGHT SIDE	NO DETECTABLE CHANGE FROM LAST GRADE PERIOD. UNPAINTED AREA (CALCAREOUS SCALE)-CLER CONDITION # 4. PAINTED AREA CLER CONDITION # 1
LEFT SIDE	NO DETECTABLE CHANGE FROM LAST GRADE PERIOD. UNPAINTED AREA (CALCAREOUS SCALE)-CLER CONDITION # 4. PAINTED AREA CLER CONDITION # 1

PHOTOGRAPH 13-PARTIAL COATINGS (MIL-P-23236) WITH ZINC ANODE

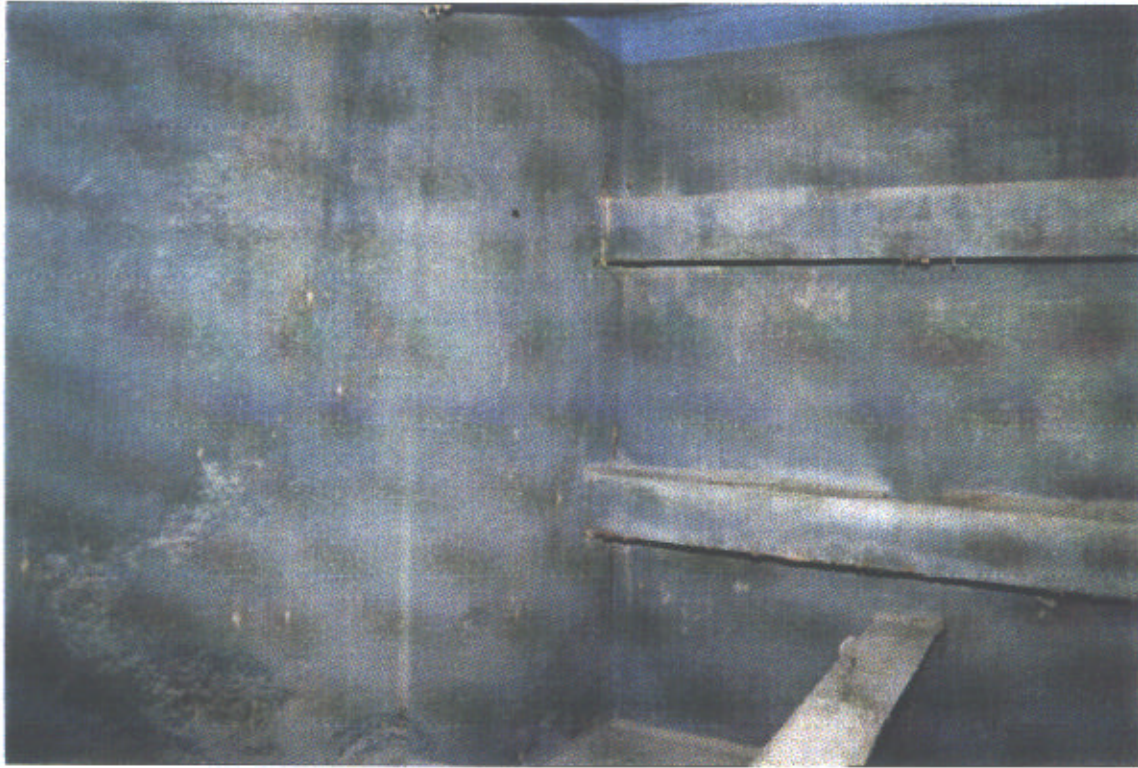
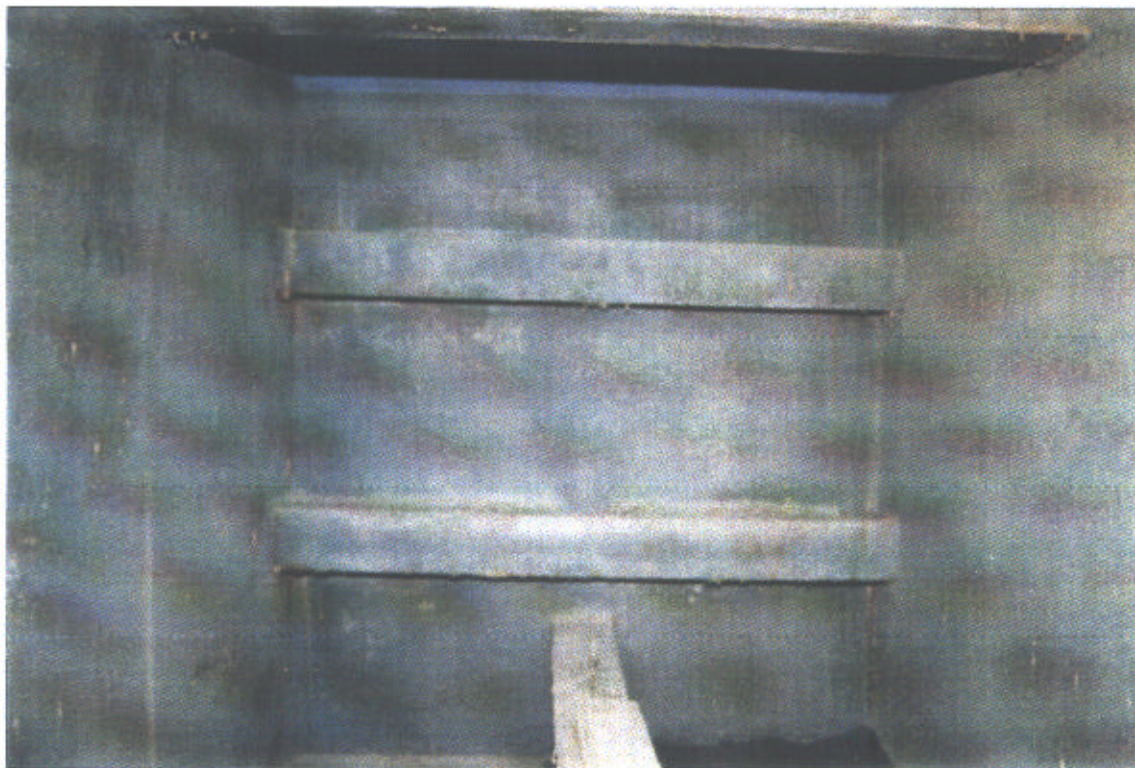
TANK SIX	COATING SYSTEM : VOC COMPLIANT INORGANIC ZINC W/ ZINC ANODE (CARBO ZINC 11HS) (SYSTEM LIFE-3 YEARS) SURFACE PREPARATION: SP-10 PREVIOUS SYSTEM: PRECONSTRUCTION ZINC PRIMER W/ZINC ANODE (SIGMA)
TOP-FLAT DFT-13 MILS	RUST GRADE 10 WITH SOME CALCARIOUS DEPOSITS. SOME OF THE DEPOSITS ARE FLAKING OFF WITH ZINC VISIBLE UNDER THE FLAKED AREA. NO RUST. CLER CONDITION # 1
TOP-STIFFENER DFT-9.5 MILS	RUST GRADE 10 WITH SOME CALCARIOUS DEPOSITS FORMING AT PINHOLES. CLER CONDITION # 1
BACK-FLAT DFT-13.3 MILS	RUST GRADE 10 WITH SOME CALCARIOUS DEPOSITS FORMING AT PINHOLES. CLER CONDITION # 1
BACK-TOP STIFFENER DFT-12.3 MILS	RUST GRADE 10 WITH SOME CALCARIOUS DEPOSITS FORMING AT PINHOLES. CLER CONDITION # 1
BACK-BOTTOM STIFFENER DFT-11.7 MILS	RUST GRADE 9 WITH SOME CALCARIOUS DEPOSITS FORMING AT PINHOLES. CLER CONDITION # 1
BOTTOM-FLAT DFT-9.5 MILS	RUST GRADE 10 WITH SOME CALCARIOUS DEPOSITS FORMING AT PINHOLES. CLER CONDITION # 1

BOTTOM- STIFFENER DFT-10.2 MILS	RUST GRADE 10 WITH SOME CALCARIOUS DEPOSITS FORMING AT PINHOLES. CLER CONDITION # 1
BOTTOM-FRAME DFT-7.6 MILS	RUST GRADE 10 WITH SOME CALCARIOUS DEPOSITS FORMING AT PINHOLES. CLER CONDITION # 1
RIGHT SIDE DFT-9.7 MILS	RUST GRADE 10 WITH SOME CALCARIOUS DEPOSITS FORMING AT PINHOLES. CLER CONDITION # 1
LEFT SIDE DFT-	RUST GRADE 10 WITH SOME CALCARIOUS DEPOSITS FORMING AT PINHOLES. CLER CONDITION # 1

PHOTOGRAPH 14-SOLVENT BASED INORGANIC ZINC WITH ZINC ANODE

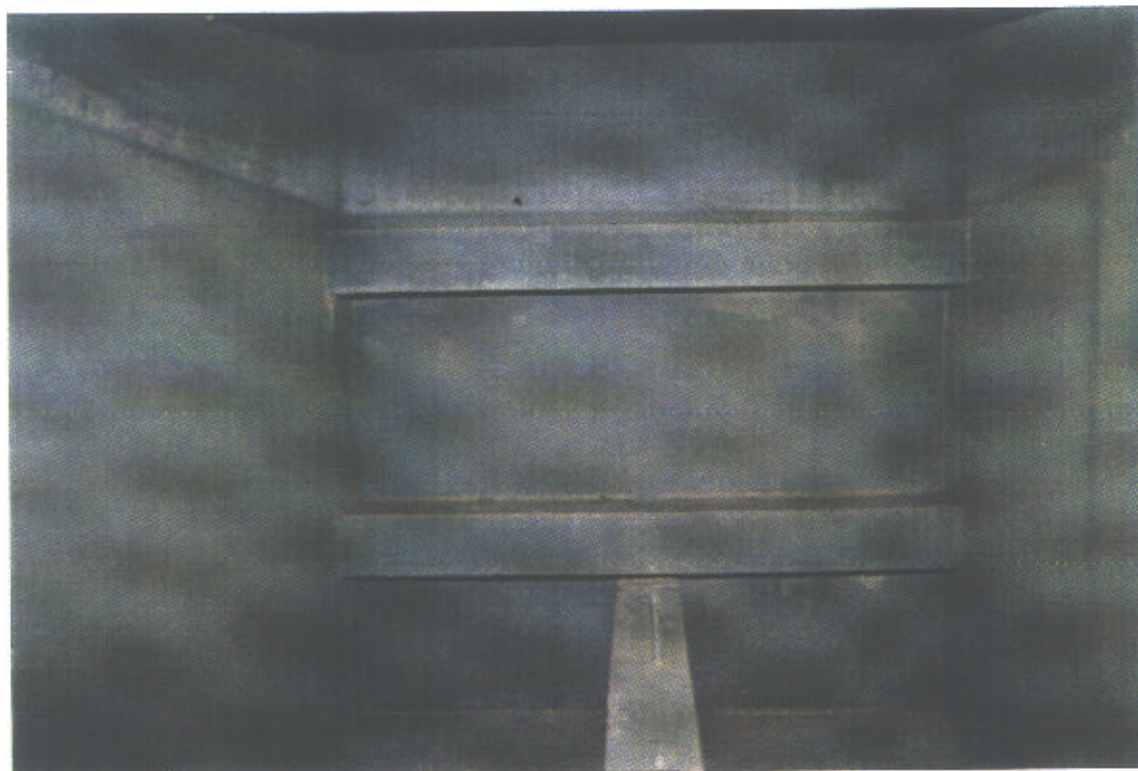
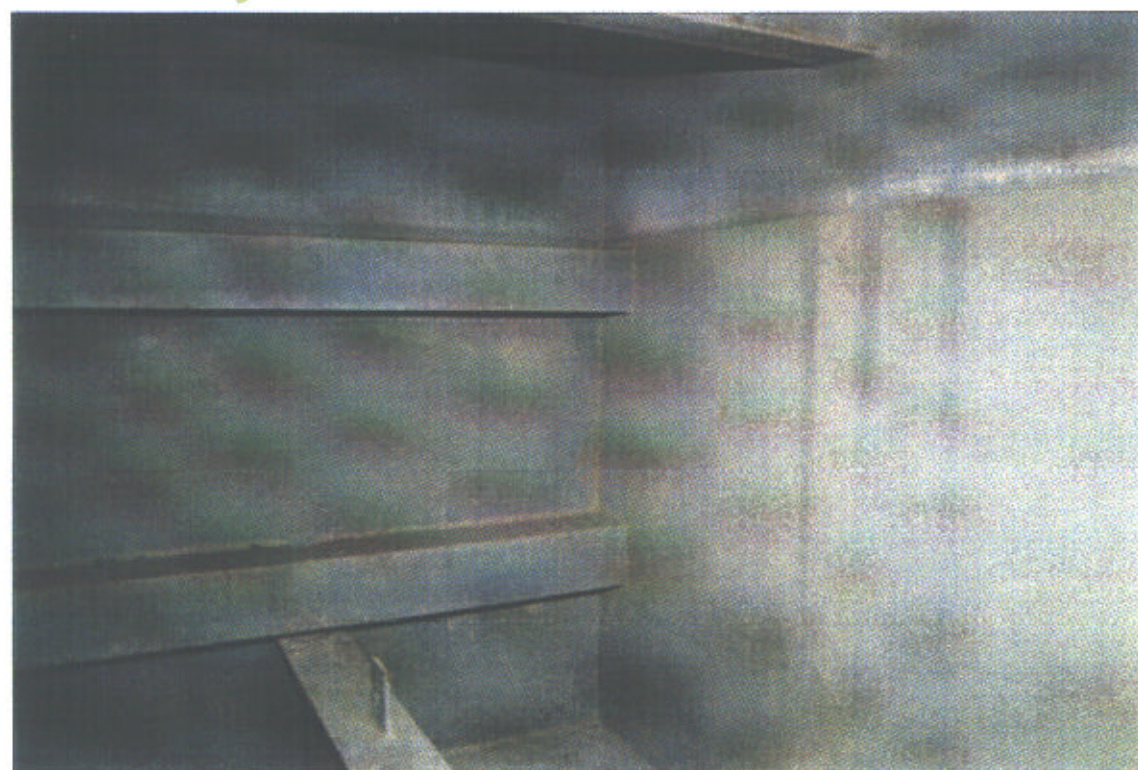
TANX NINE	COATING SYSTEM : VOC COMPLIANT INORGANIC ZINC (NO ANODES) (CARBO ZINC 11HS) (SYSTEM LIFE-3 YEARS) SURFACE PREPARATION: SP-10 PREVIOUS SYSTEM: SURFACE TOLERANT SYSTEM B
TOP-FLAT DFT-13.9 MILS	RUST GRADE 10 WITH SOME CALCARIOUS DEPOSITS FORMING AT PINHOLES. CLER CONDITION # 1
TOP-STIFFENER DFT-9.1 MILS	RUST GRADE 9 WITH SOME CALCARIOUS DEPOSITS FORMING AT PINHOLES. SOME EDGE FAILURE BEGINNING. CLER CONDITION # 2
BACK-FLAT DFT-9.2 MILS	RUST GRADE 10 WITH SOME CALCARIOUS DEPOSITS FORMING AT PINHOLES. CLER CONDITION # 1
BACK-TOP STIFFENER DFT-11.9 MILS	RUST GRADE 10 WITH SOME CALCARIOUS DEPOSITS FORMING AT PINHOLES. CLER CONDITION # 1
BACK-BOTTOM STIFFENER DFT-7.3 MILS	RUST GRADE 10 WITH SOME CALCARIOUS DEPOSITS FORMING AT PINHOLES. CLER CONDITION # 1
BOTTOM-FLAT DFT-11.7 MILS	RUST GRADE 10 WITH SOME CALCARIOUS DEPOSITS FORMING AT PINHOLES. CLER CONDITION # 1
BOTTOM-STIFFENER DFT-8.5 MILS	AREA APPROXIMATELY 6 INCHES BY 4 INCHES ON RIGHT SIDE DELAMINATED WITH CALCARIOUS DEPOSIT UNDER THE DELAMINATED AREA. ZINC VISIBLE UNDER DELAMINATED AREA. BALANCE RUST GRADE 10. CLER CONDITION # 2

PHOTOGRAPH 15-SOLVENT BASED INORGANIC ZINC

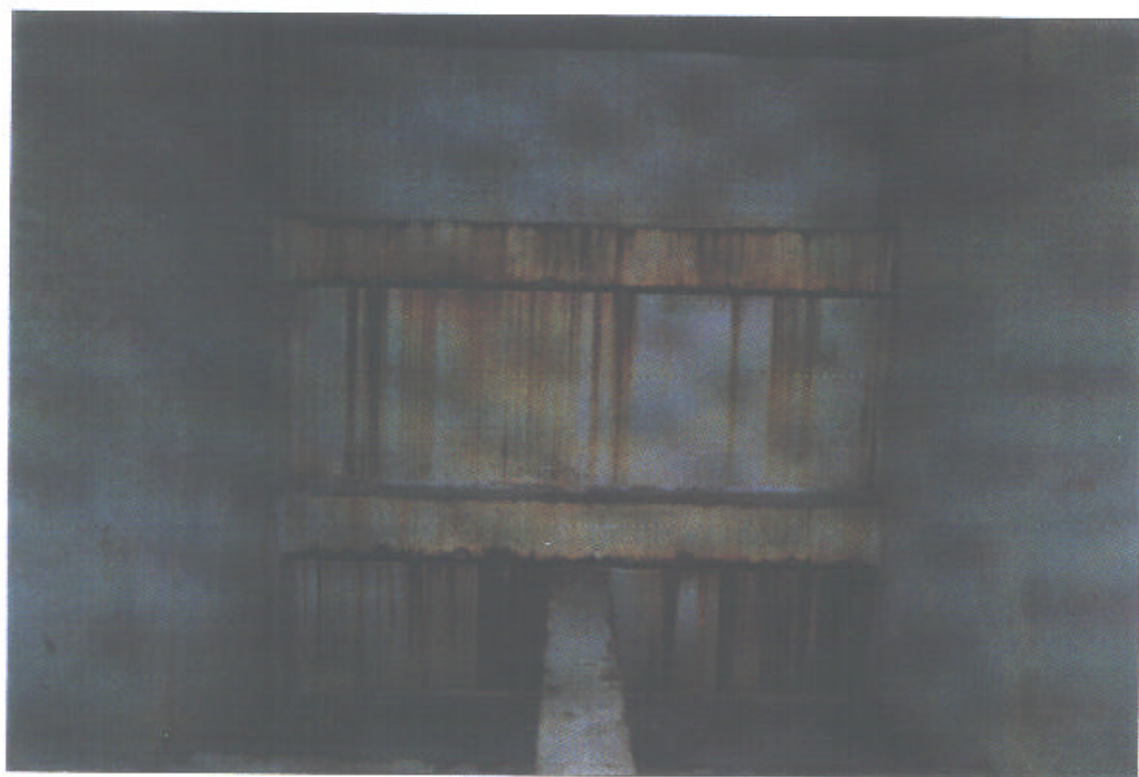
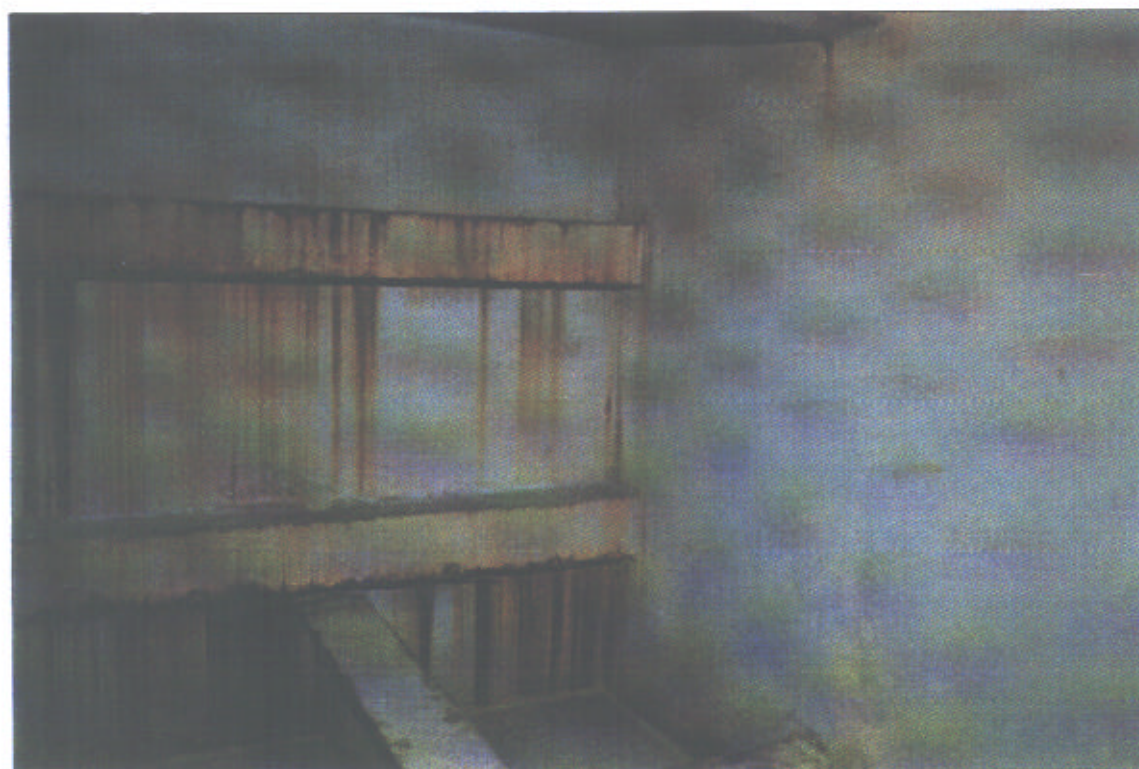
under test for five years. This system is beginning to fail. The top overhead stiffener has failed with edge exfoliation. The top back stiffener has also failed. The balance of the flats range from rust grade 7 to 8. See photograph 16.

TANK EIGHT	COATING SYSTEM: WATERBORNE HIGH RATIO INORGANIC ZINC (INORGANIC COATINGS) SURFACE PREPARATION: SP-10 PREVIOUS SYSTEM: SAME. (SYSTEM LIFE FIVE YEARS)
TOP-FLAT DFT-7.2 MILS	RUST GRADE 9 CLER CONDITION # 1
TOP-STIFFENER DFT-	EDGE BREAKDOWN WITH EXFOLIATION. LEFT HALF FAILED. RIGHT HALF AND BACK SIDE RUST GRADE 8. CLER CONDITION # 3
BACK-FLAT DFT-7.8 MILS	RUST GRADE 9 WITH RUST STREAKING. CLER CONDITION # 2
BACK-TOP STIFFENER DFT-	TOP FAILED. RUST STREAKING. STEEL DELAMINATION/EXFOLIATION FROM RUST UNDER INORGANIC ZINC COATING. CLER CONDITION # 4
BACK-BOTTOM STIFFENER DFT-	EDGE FAILURE. BALANCE RUST GRADE 8. CLER CONDITION # 3
BOTTOM-FLAT DFT-9.4 MILS	RUST GRADE 7 CLER CONDITION # 3
BOTTOM-STIFFENER DFT-	RIGHT SIDE FAILED. LEFT SIDE BEGINNING TO BREAKDOWN. BALANCE RUST GRADE 8 ON LEFT SIDE; RUST GRADE 4 ON RIGHT SIDE. CLER CONDITION # 4
BOTTOM-FRAME DFT-	BACK SIDE RUST GRADE 7. FRONT SIDE RUST GRADE 6. TOP RUST GRADE 10. UNDERSIDE OF FLANGE TOTAL FAILURE. CLER CONDITION # 3

RIGHT SIDE DFT-5.6 MILS	BOTTOM FRONT FAILED 6 INCHES UP FROM BOTTOM. BALANCE RUST GRADE 9. CLER CONDITION # 2
LEFT SIDE DFT-7.4 MILS	RUST GRADE 8 CLER CONDITION # 2

PHOTOGRAPH 16-HIGH RATIO INORGANIC ZINC
